THE
GREAT EARTHQUAKE
OF JAPAN

1891.

BY
JOHN MILNE.
AND
W.K. BURTON.
PLATES BY K. OGAWA.

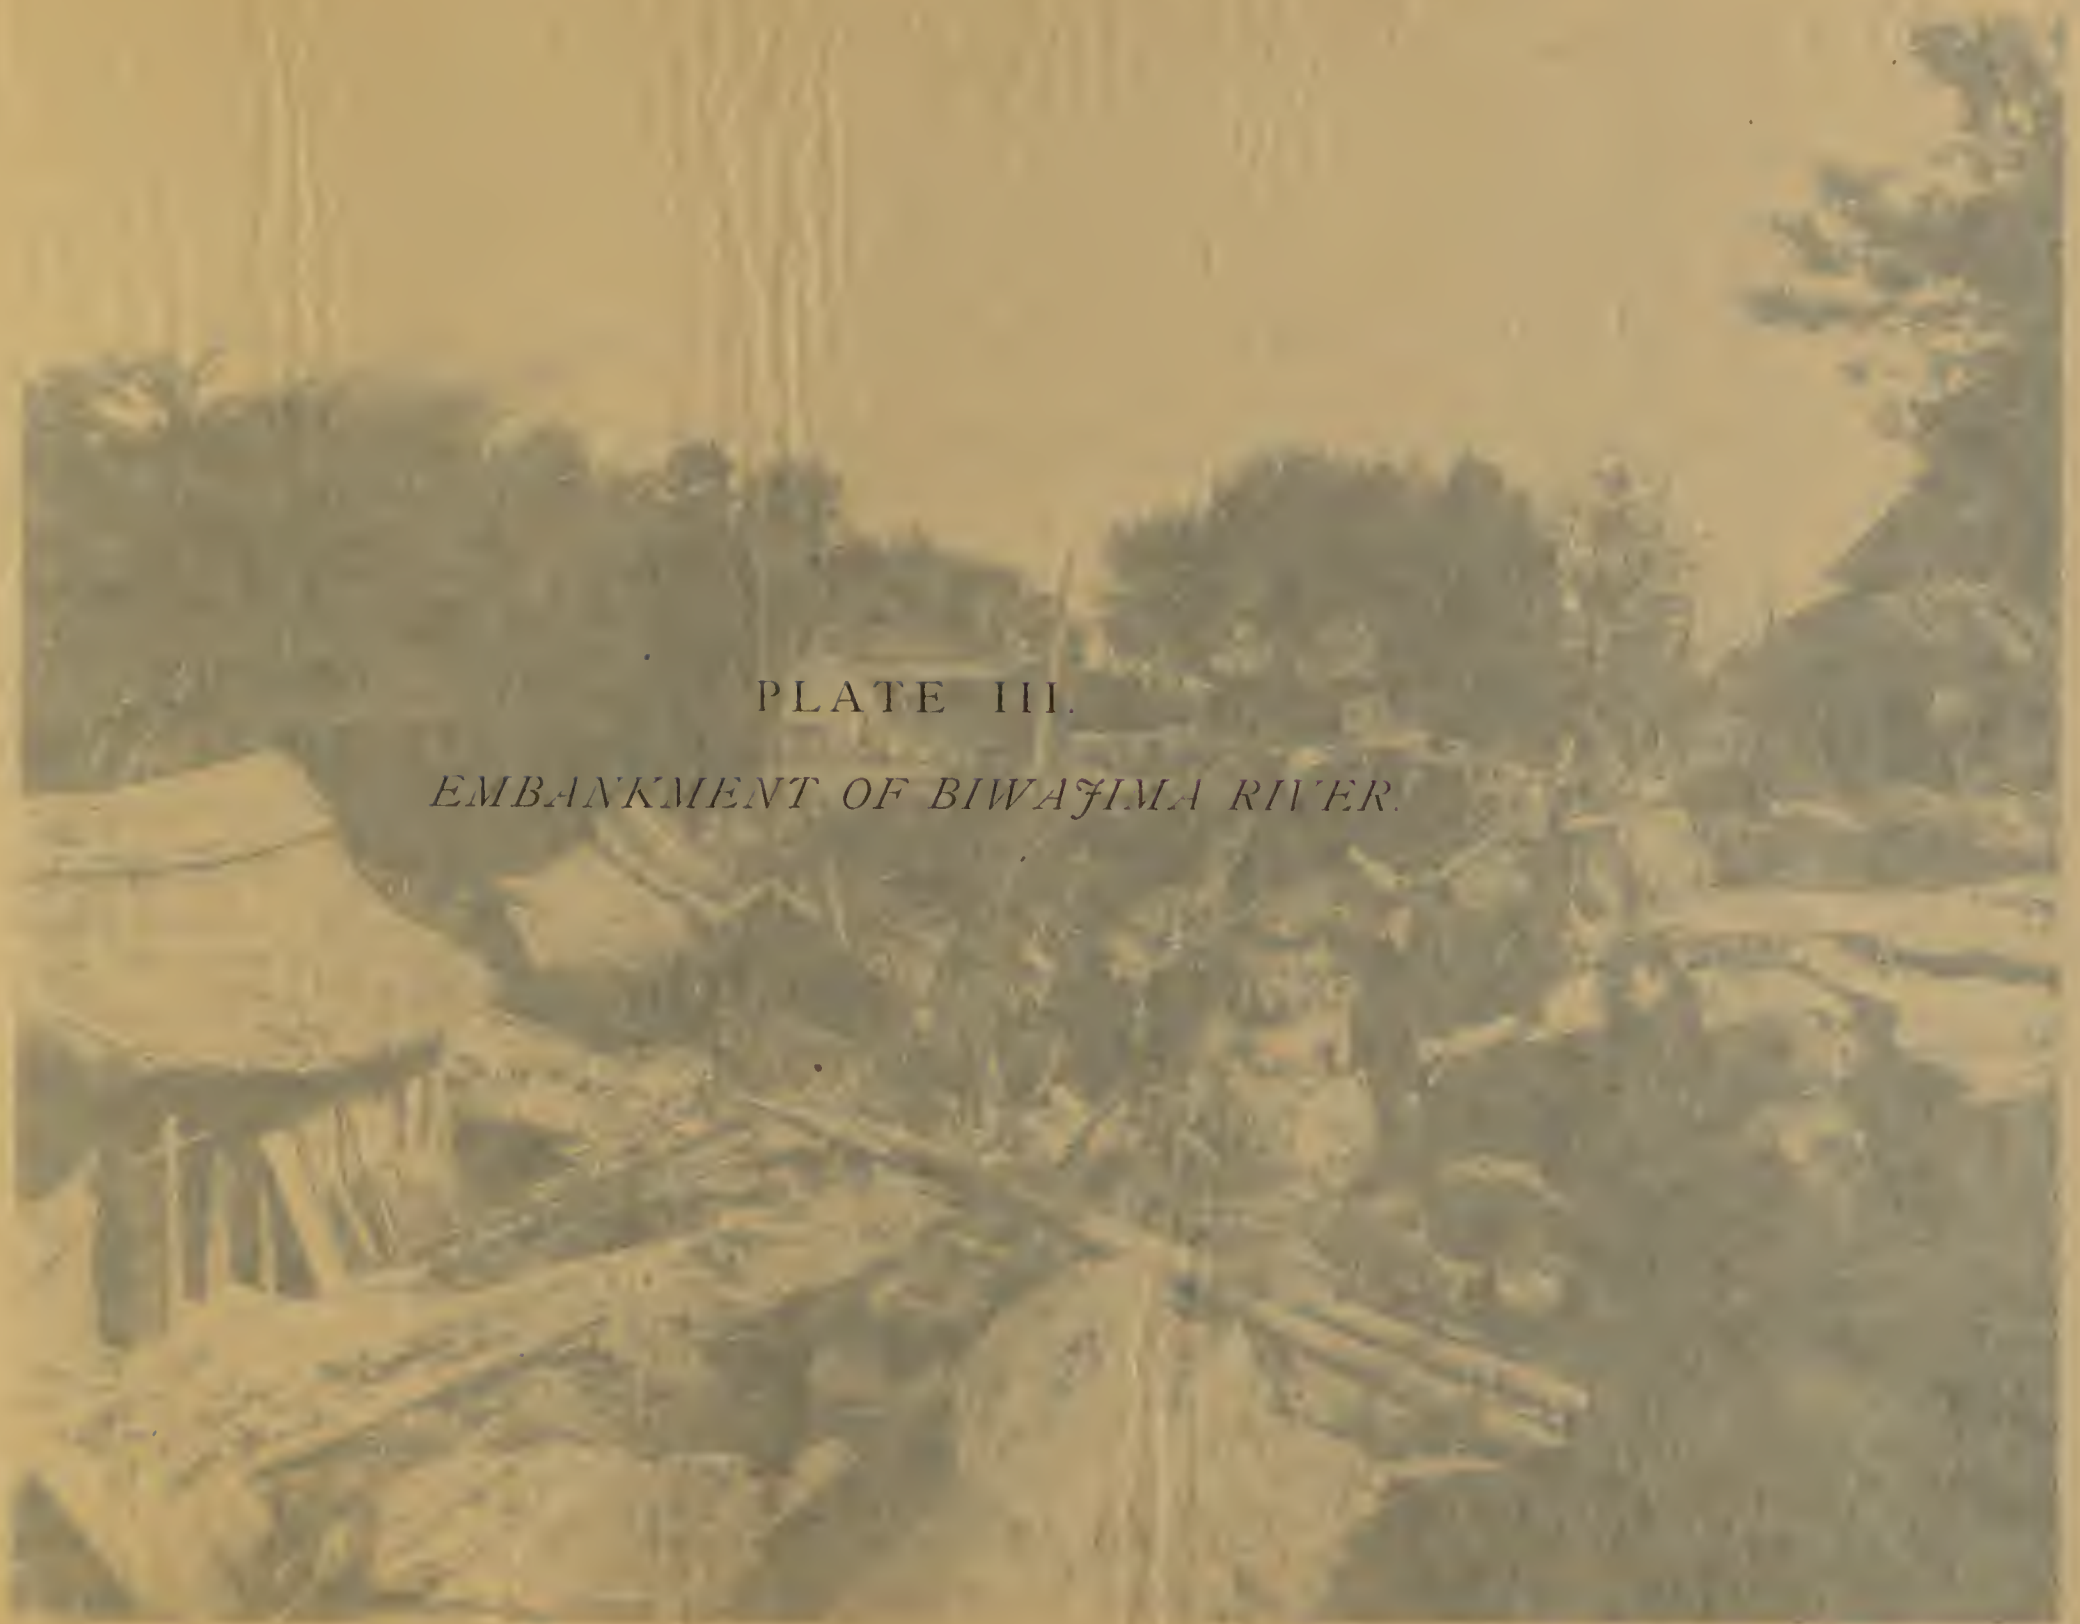
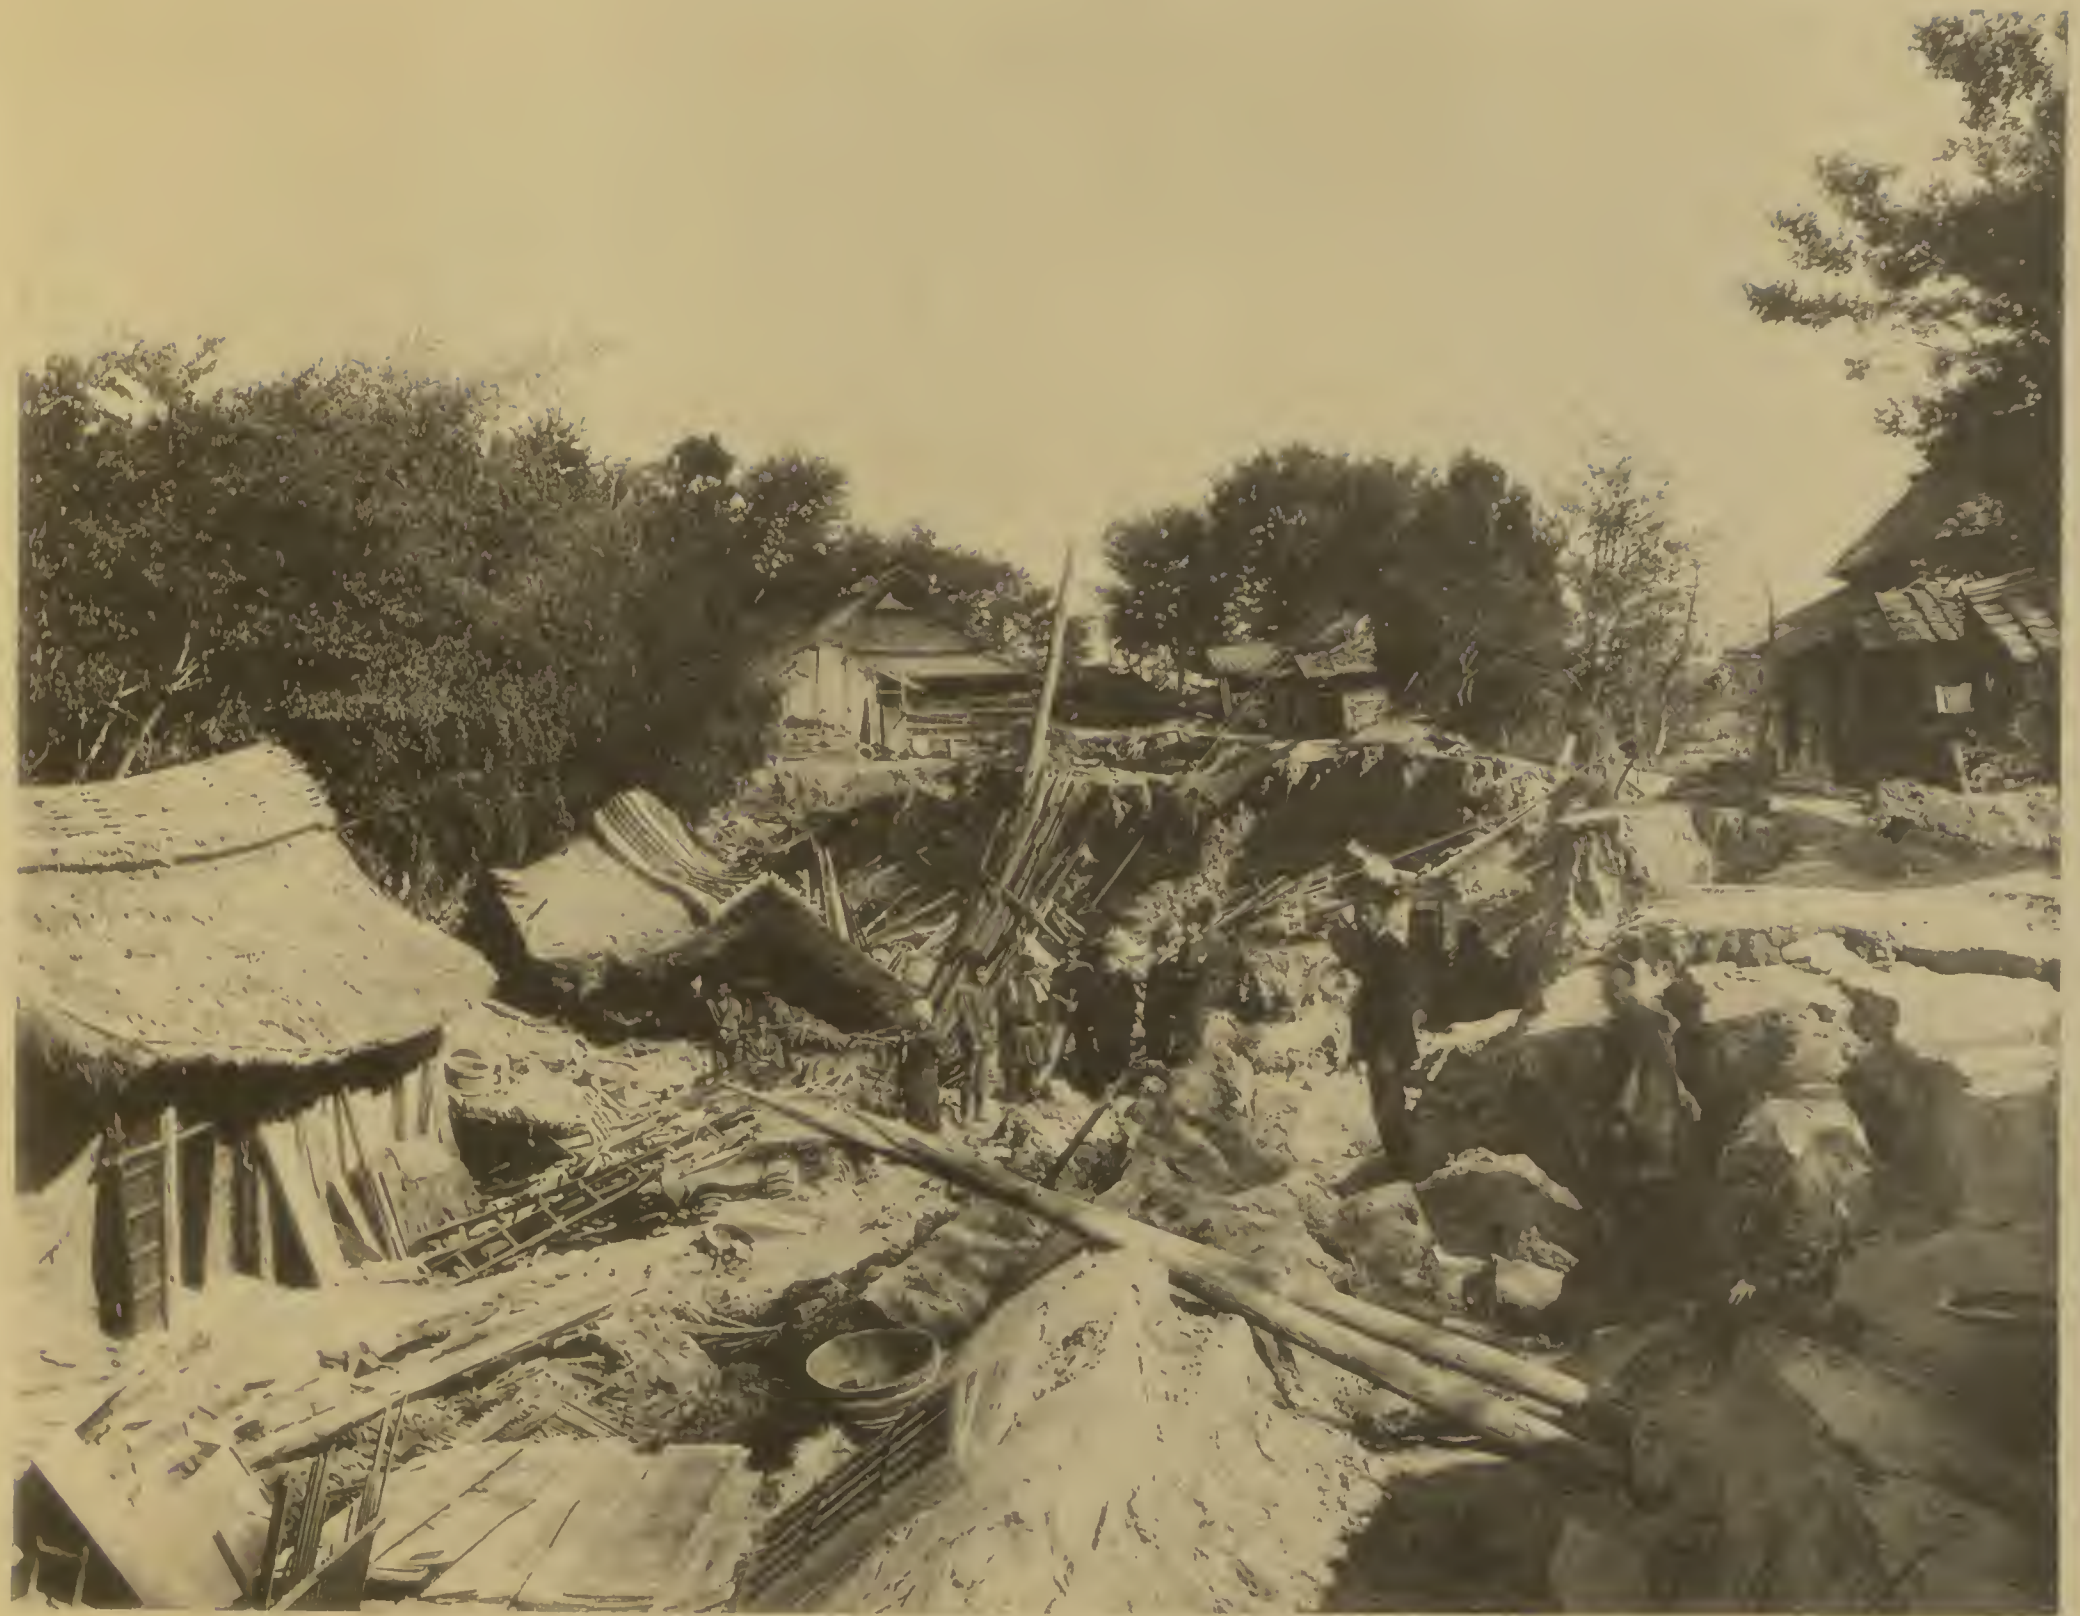
PLATE III.

EMBANKMENT OF BIWAJIMA RIVER.

The fracture shows the kind of destruction which has occurred along the banks for a distance of several miles near Biwajima. There are innumerable longitudinal clefts of all widths up to about two feet, and the inner half of the embankment has slid down towards the river to greater or less distances from a few inches to a number of feet measured vertically.

At one place the embankment is entirely gone for a couple of hundred feet or so, and here a very strange thing has happened. There was a large bamboo grove and a few pine trees just at the back—the side away from the river—of the embankment, and this little forest has slid,—been pushed or call it what you will—sixty feet back, yet the bamboos and trees remain upright!

One thatched roof, it will be noticed, has fallen intact, and it is in this manner that most of the farmers houses, which so thickly cover the Nagoya-Gifu plain, have given way and the country is now dotted over with these roofs, which from a distance present the appearance of gigantic saddles.

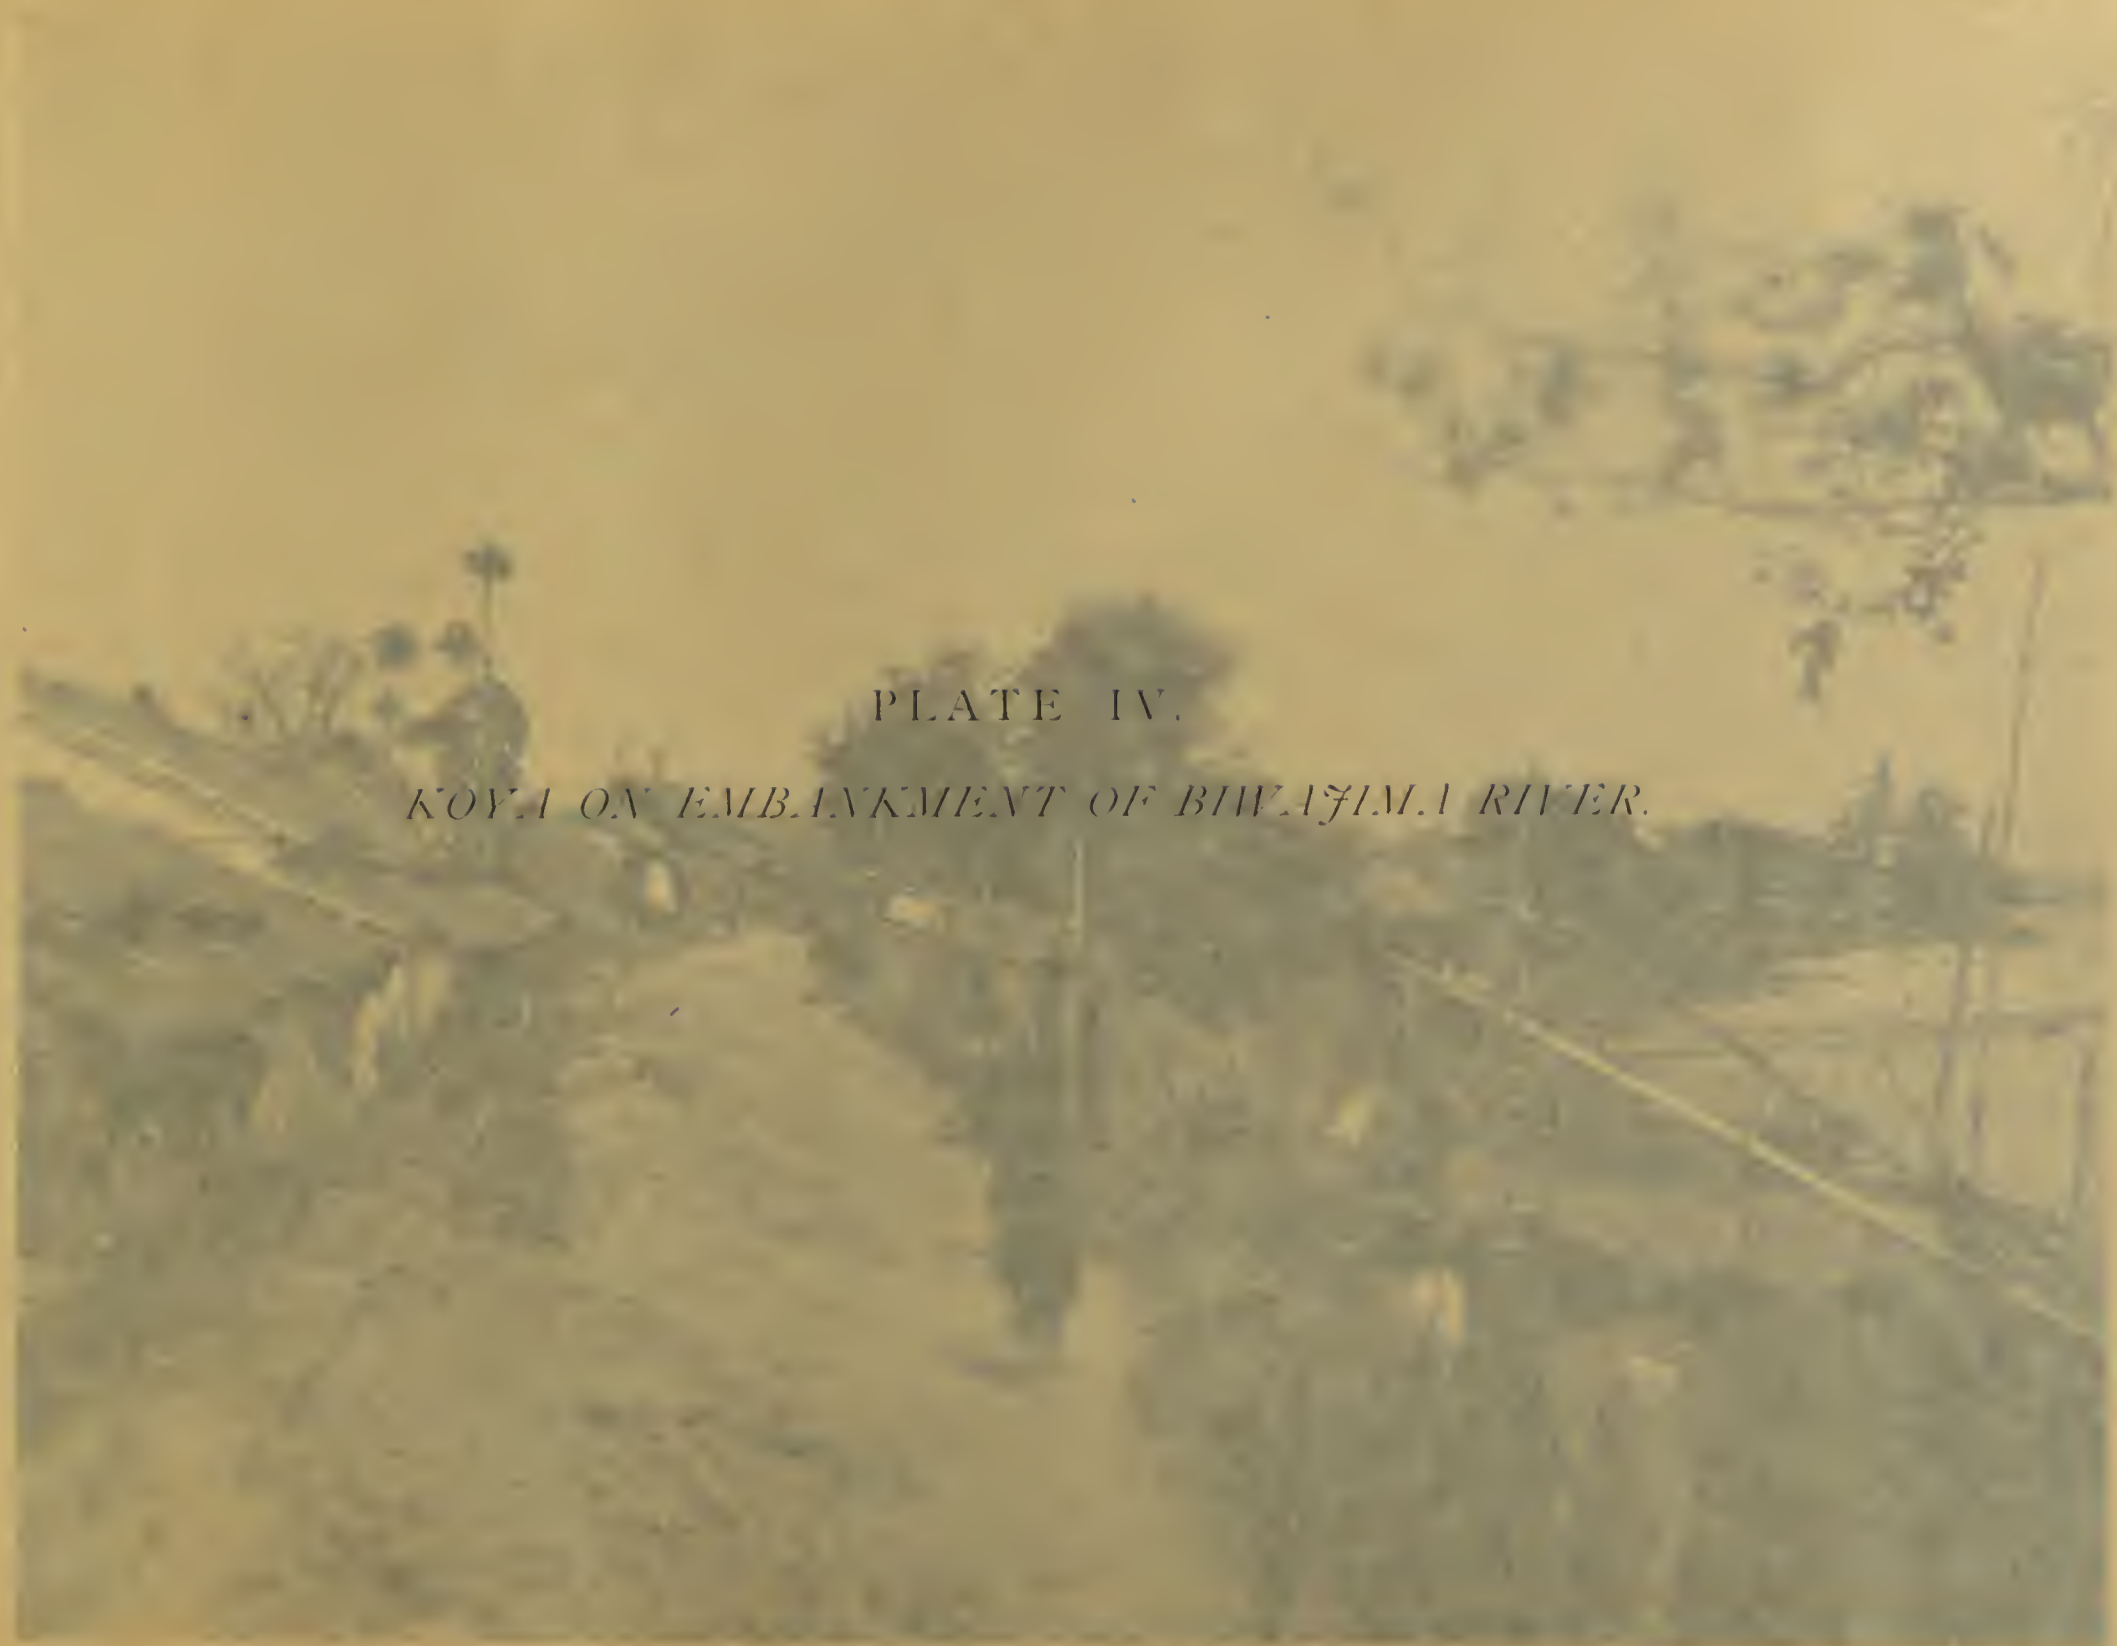
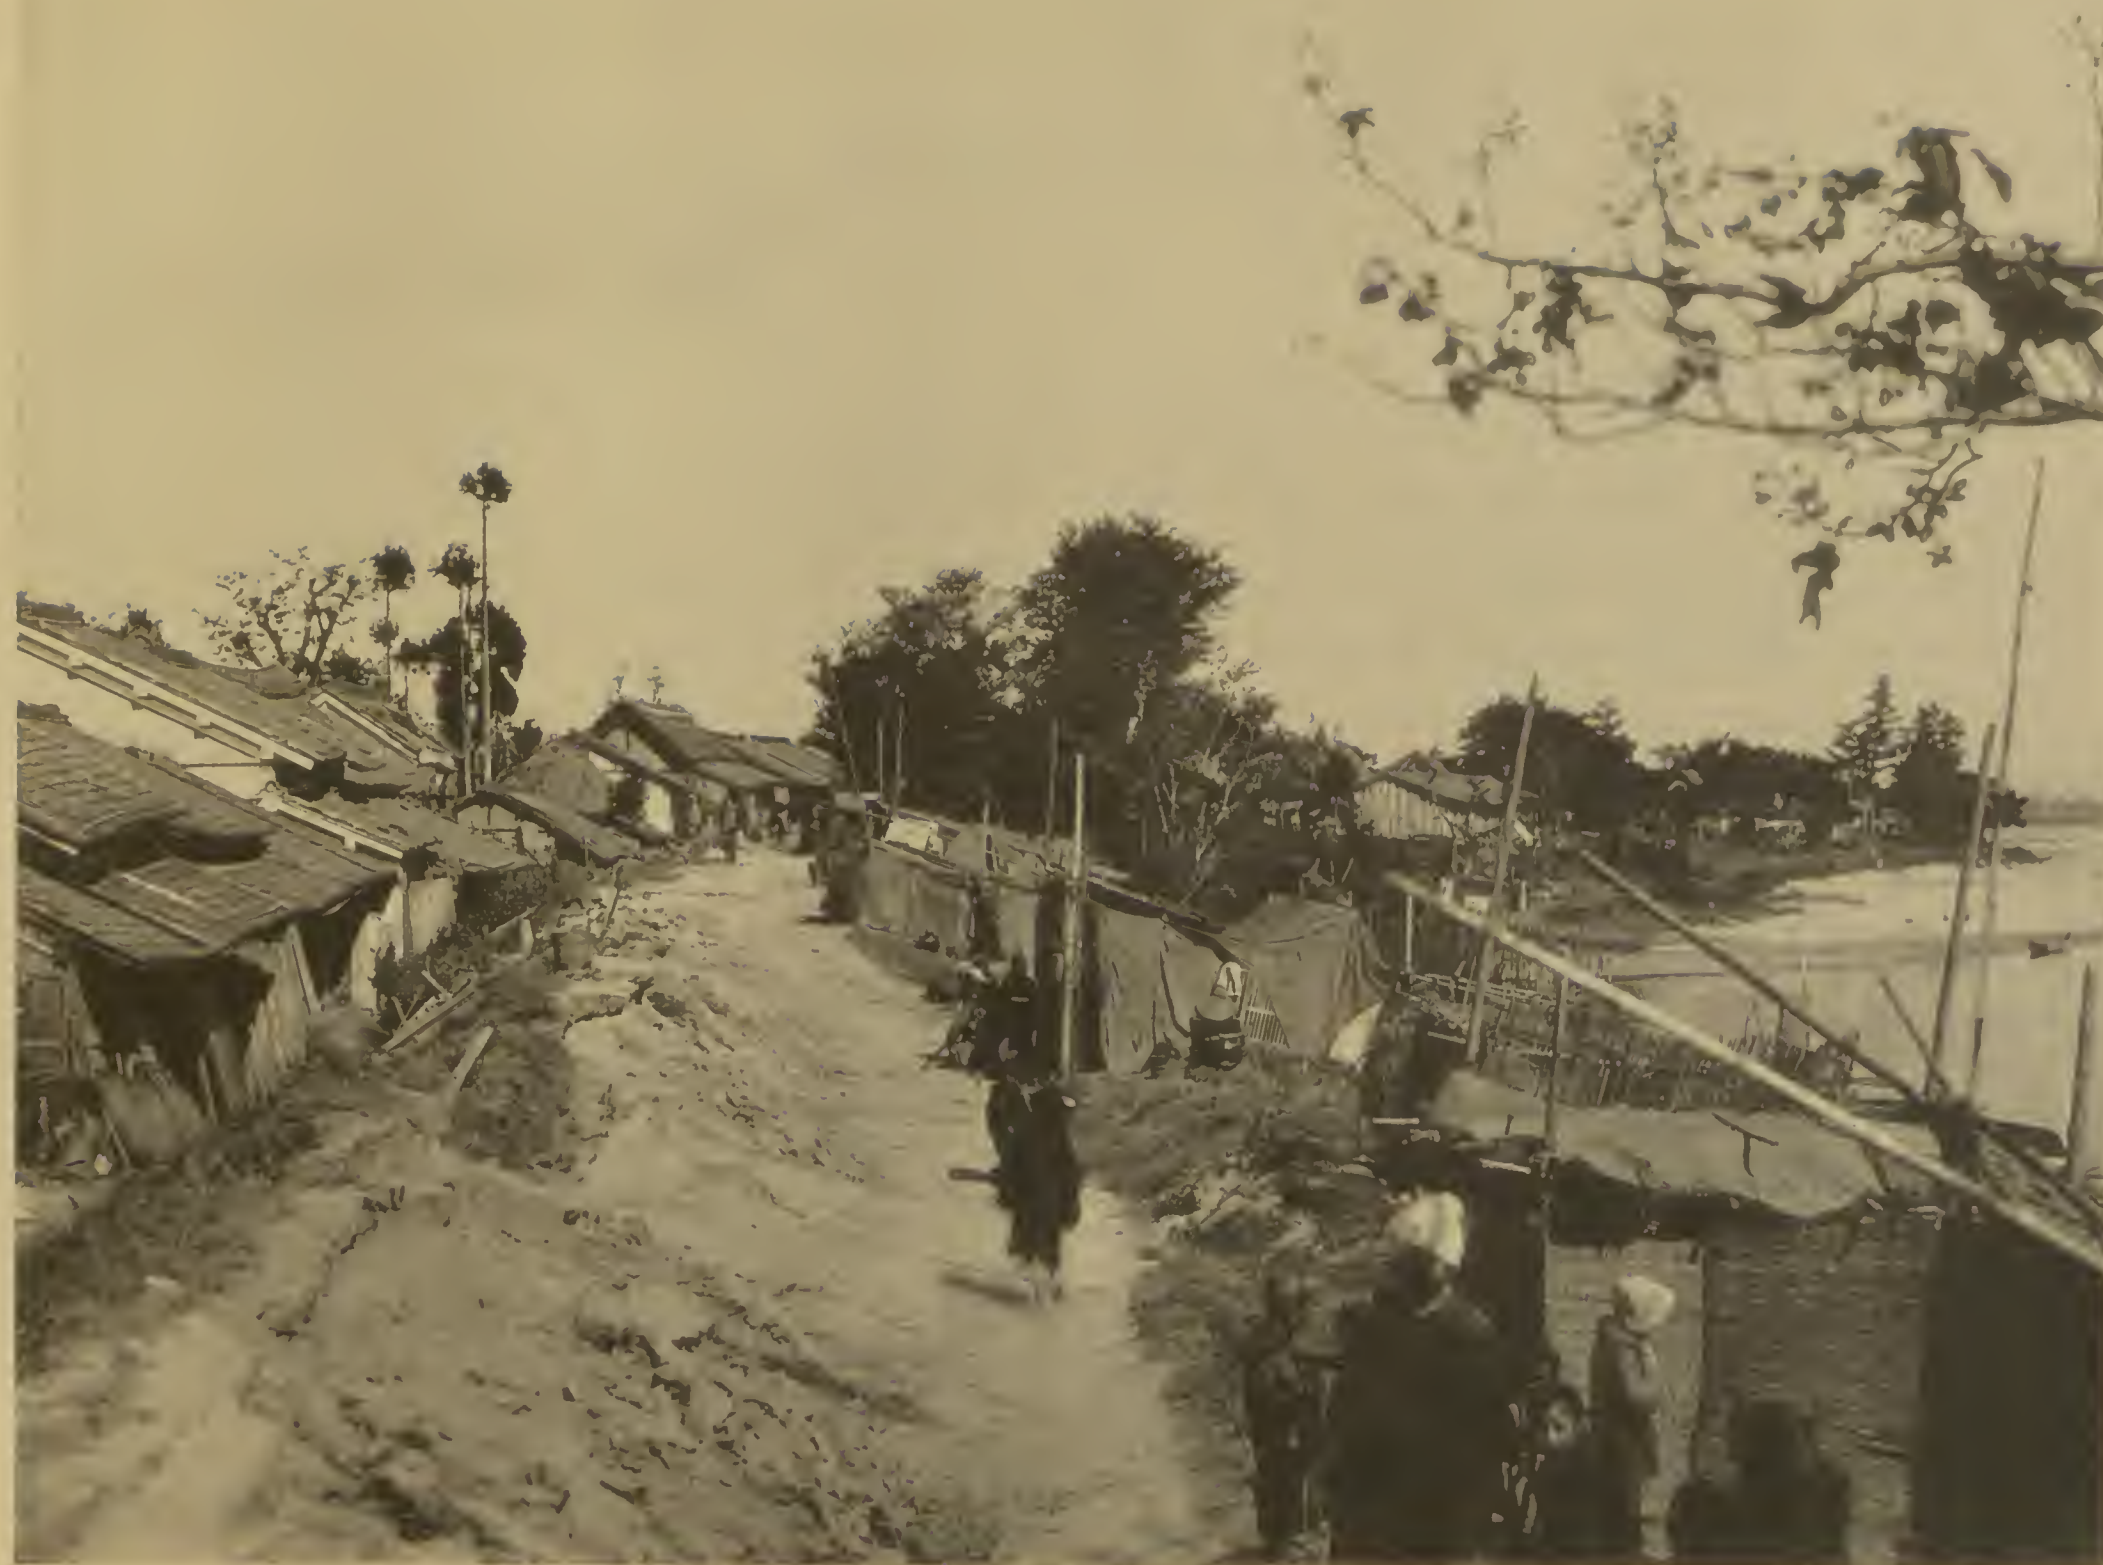
PLATE IV.

KOYI ON EMBANKMENT OF BIWAJIMA RIVER.

IN this picture we again see the movement which has taken place along the river bank. On the left are a few tiled houses yet standing, and on the right the temporary huts—called *koya*—built out of mats, screens, or whatever could be procured, in which the frightened survivors are living.

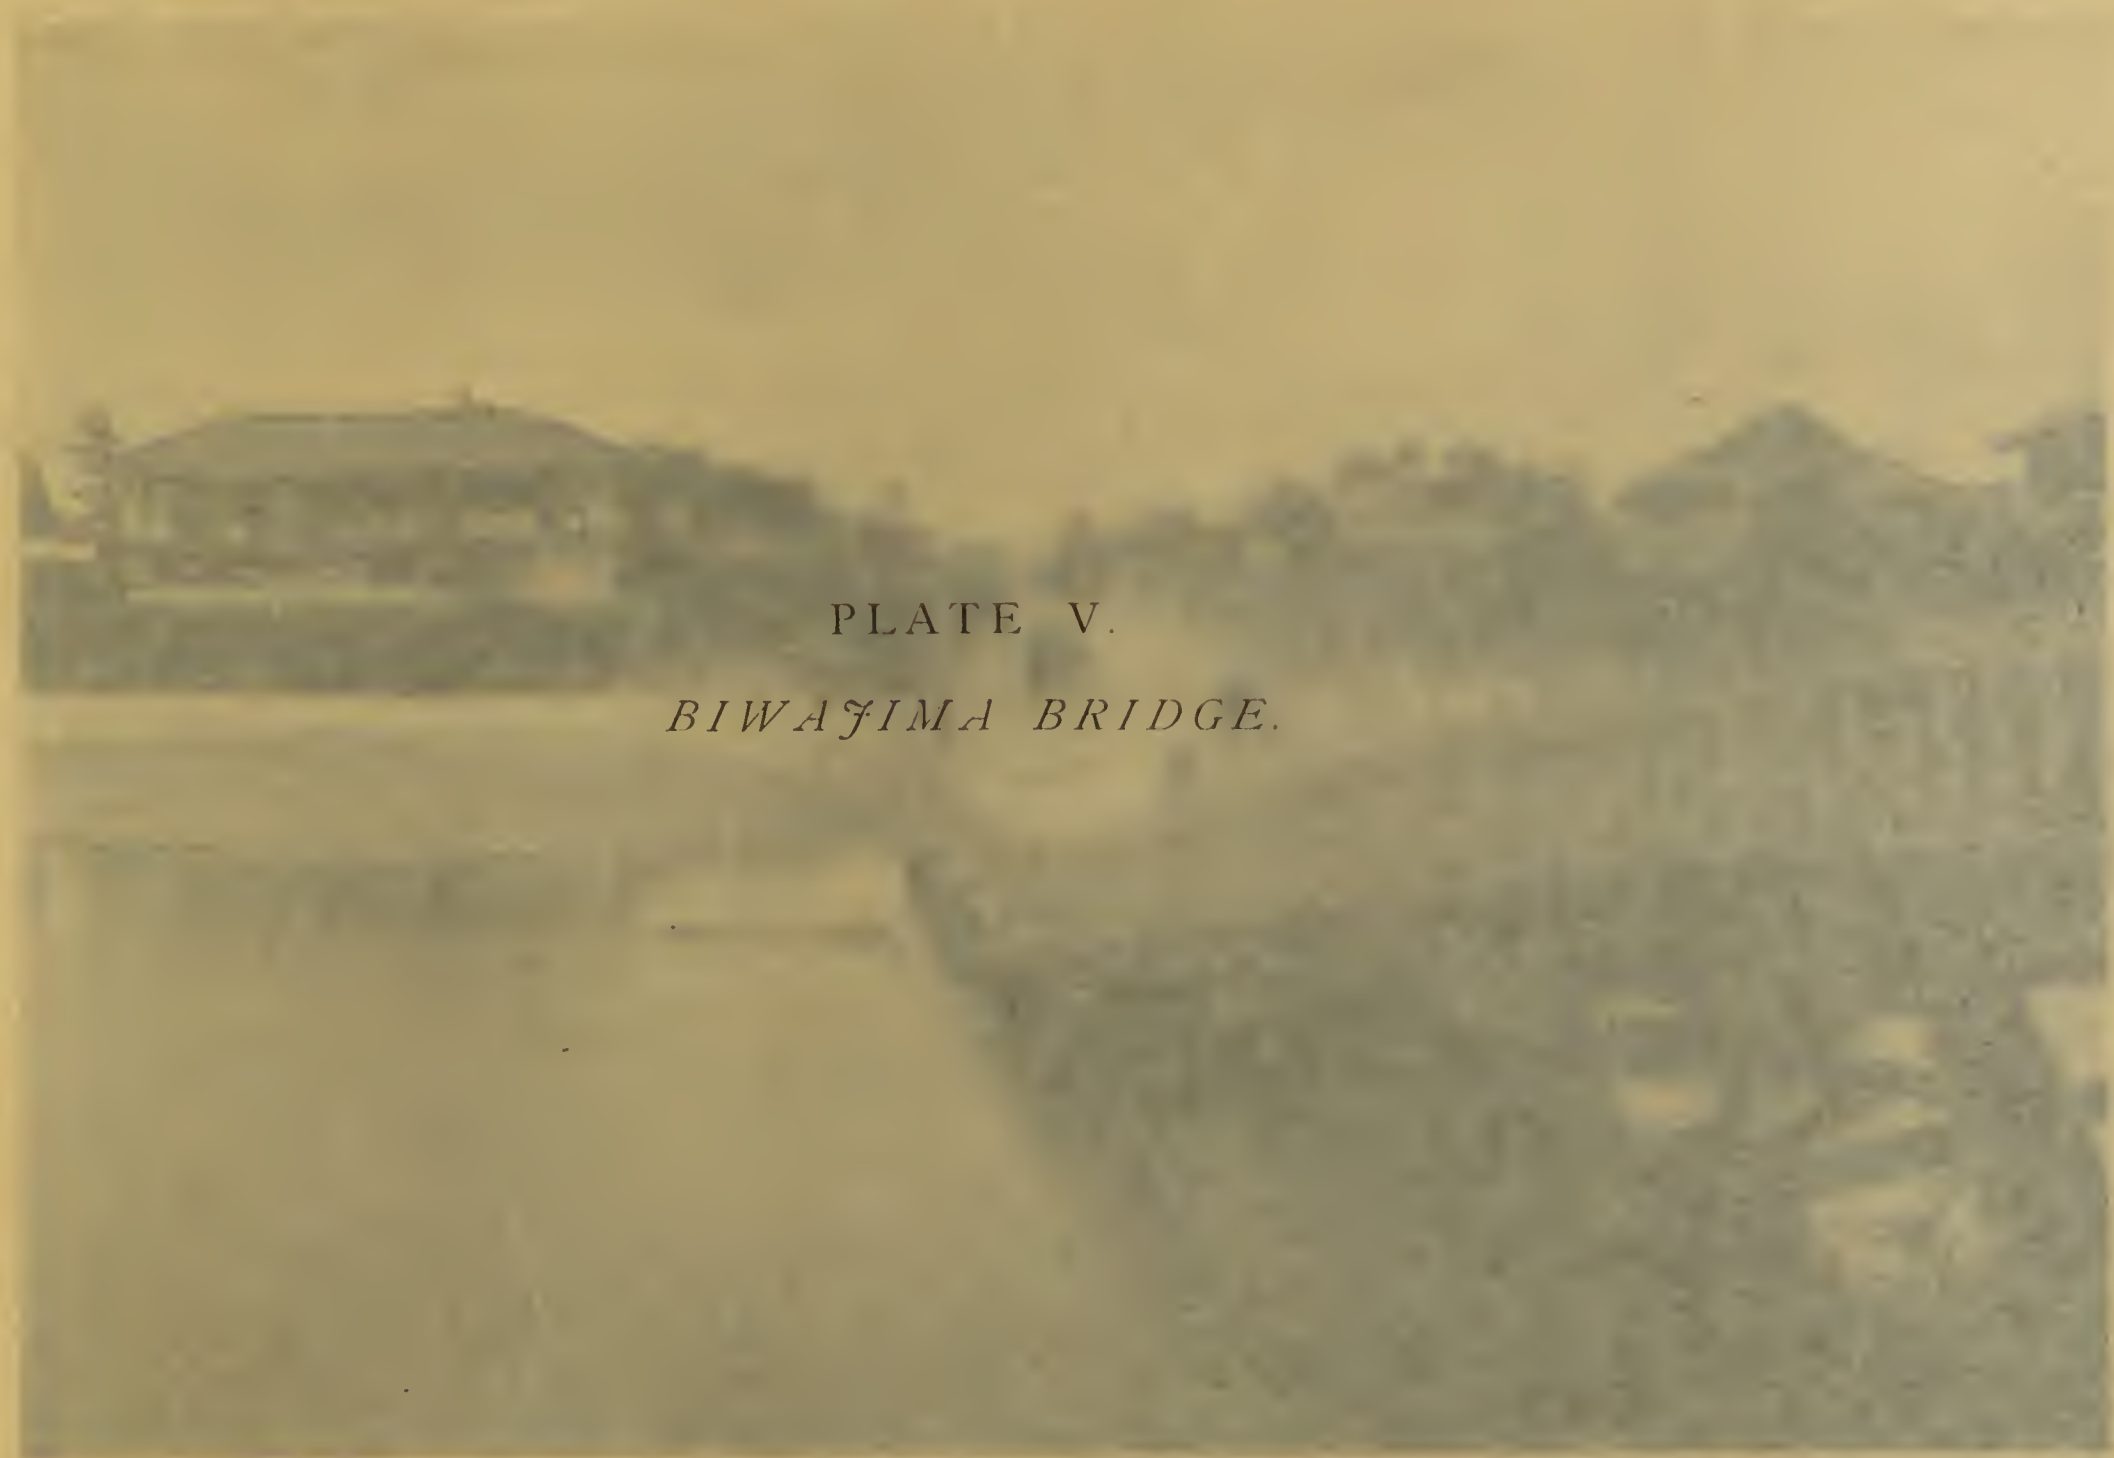
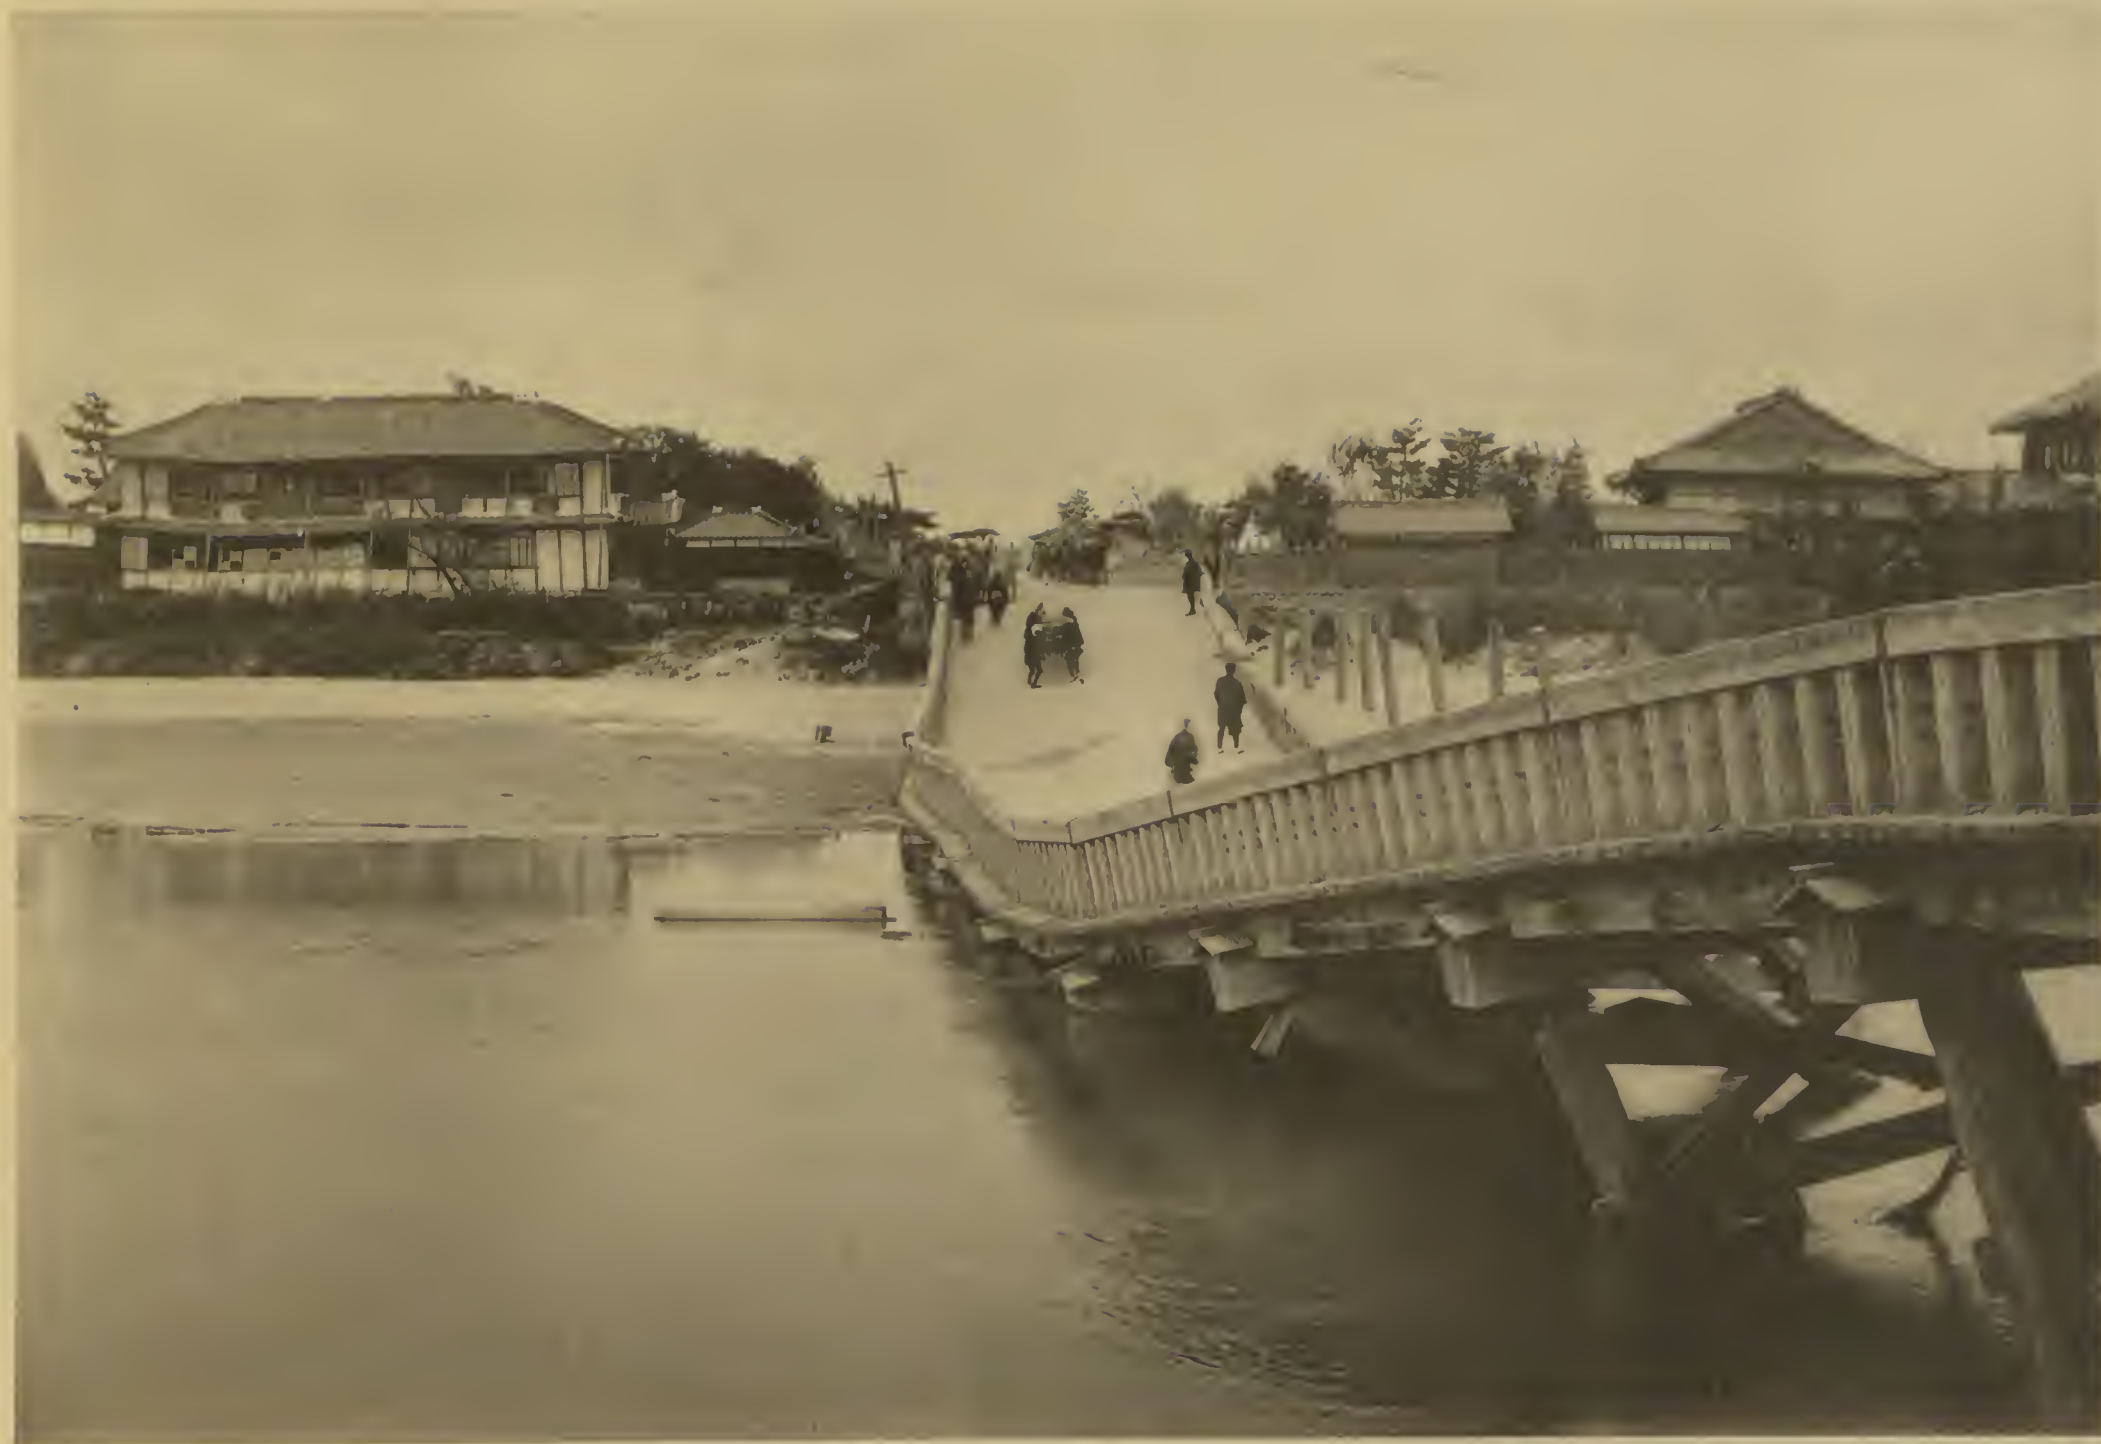
PLATE V.

BIWAJIMA BRIDGE.

HE Biwajima-bashi, a wide wooden carriage bridge across the Shōnaigawa, has been completely wrecked. It lies in the bed of the river in a curious serpent-like twisted form. The river is very low, and the continuity of the bridge is nowhere actually broken, so it is possible to walk across, though the feat is not a very easy one on account of the angle at which the footway is canted.

The river banks and the houses standing on them are fairly intact, suggesting the idea—which is, however, difficult to conceive—that the river bed had transmitted a greater quantity of motion than the banks.
